New Zealand Refining Company Bearing Solution

High Vacuum Column Bottom Pump

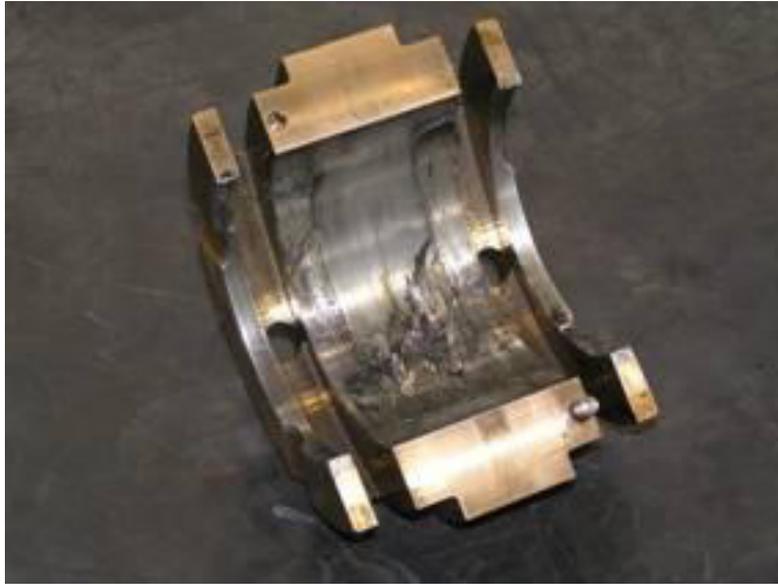
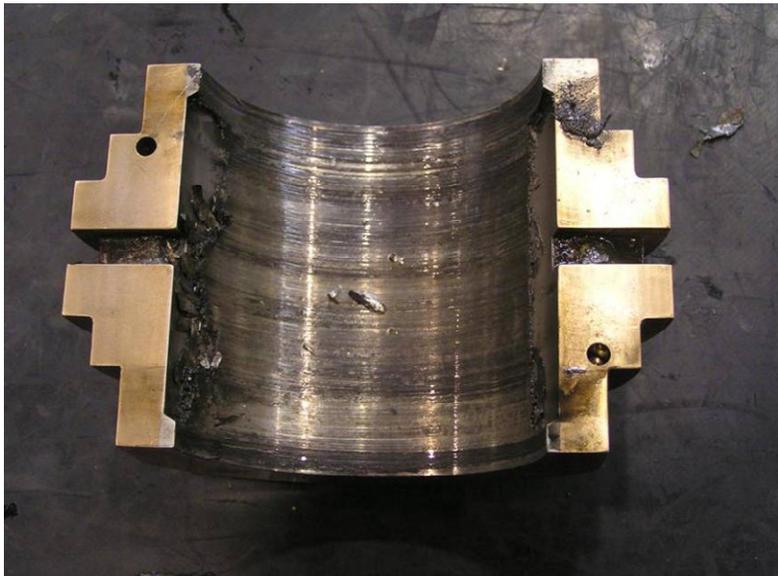
Typical symptoms included discolouration of the lube oil due to white metal contamination and high temperatures observed on the bearing housings. Resorting to hand cut oil distribution grooves in the linings kept the problem under control, but whenever replacement bearings were fitted the problems re-surfaced.

Once again the new bearings began to suffer with lube oil discolouration and high running temperatures being observed.

Wiped Bearing – Original Design

A fully wiped bearing raised the profile of the problem and prompted a call for assistance to a plain bearing specialist, Alloy Bearings.

Based on this experience they proposed a number of minor modifications to the bearing geometry and detail. The modifications were intended to maximise the flow of cool oil from the sump through the bearings thus increasing oil film thickness and reducing temperatures.

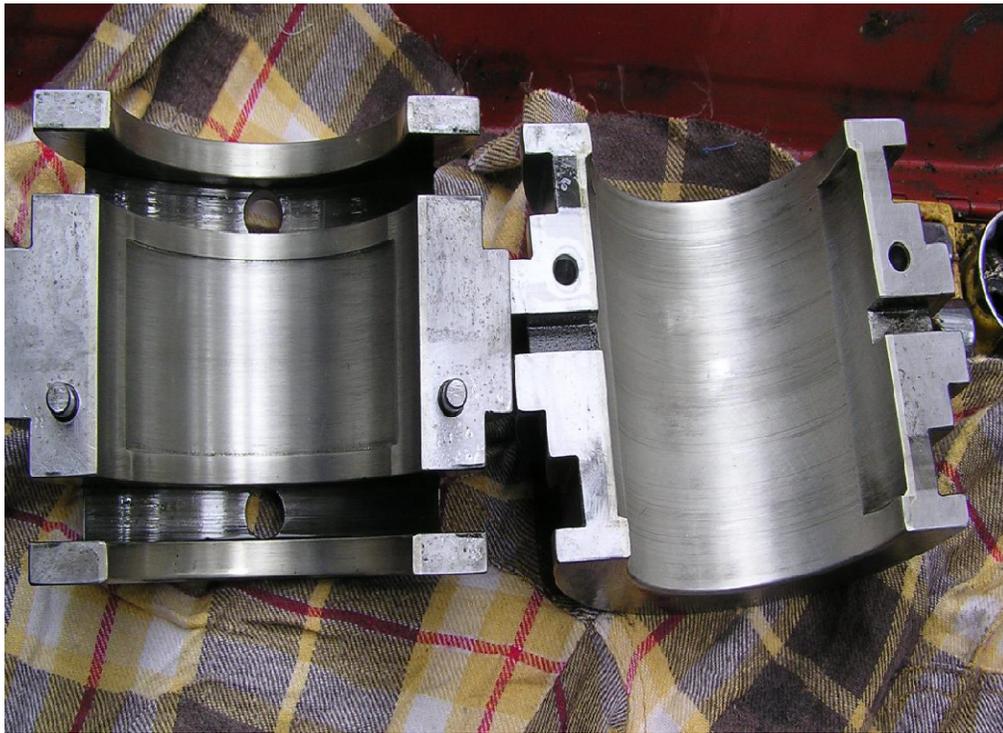
Operational tests were undertaken and the bearing housing temperatures were now 13 degrees C lower than previous.

After four months of use the pump was stopped for an inspection of the bearings. Close examination showed no evidence of overheating or abnormal wear patterns, but unfortunately some scratching of the bearings had occurred due to the early foreign particle contamination at initial start up.

New Design Bearing After Proving Run

The new bearing geometry and design is considered a complete success and replacement bearings have been ordered for the second pump.
